*Grattan Township and Grattan/Vergennes Sewer Systems Monthly Report  
November 2009*

## Grattan Township Sewer System

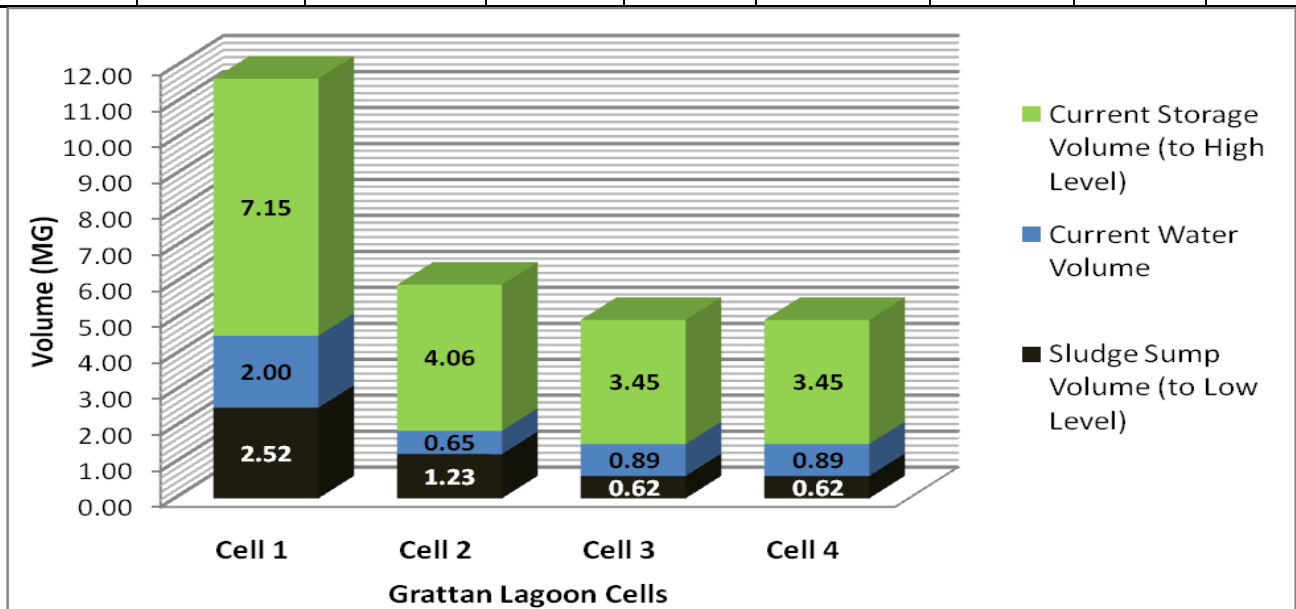
A snapshot of the individual and total lagoon volume and storage for November 25, 2009 are shown below. More detailed weekly data can be prepared on request. The daily flow from BPI-PS #1 along with weekly lagoon levels will be recorded and plotted during the time of storage.

Nov. 25, 2009 Lagoon Levels	Feet Below Transfer / Pumping Structure Grating	Water Elevation (Top Structure Grating= 905.5')	Current Total Volume*	Low Water Volume (Sludge Sump)*	Current Water Volume (Current Volume Minus Sump Volume)*	Current Storage Volume (To High Water Level)	Total WWTF Current Volume	Total WWTF Storage Volume (to High Water Level)
Cell 1	7.44 ft	898.06 ft	4.52 MG	2.52 MG	2.00 MG	7.15 MG	9.42 MG	18.11 MG
Cell 2	7.87 ft	897.63 ft	1.88 MG	1.23 MG	0.65 MG	4.06 MG		
Cell 3	10.87 ft	894.63 ft	1.51 MG	0.62 MG	0.89 MG	3.45 MG		
Cell 4	10.87 ft	894.63 ft	1.51 MG	0.62 MG	0.89 MG	3.45 MG

\*Data obtained from Prein&Newhof Lagoon Volume Calculator.
