***Grattan Township and Grattan/Vergennes Sewer Systems Monthly  
Operations Report***

**February 2010**

## Grattan Township Sewer System

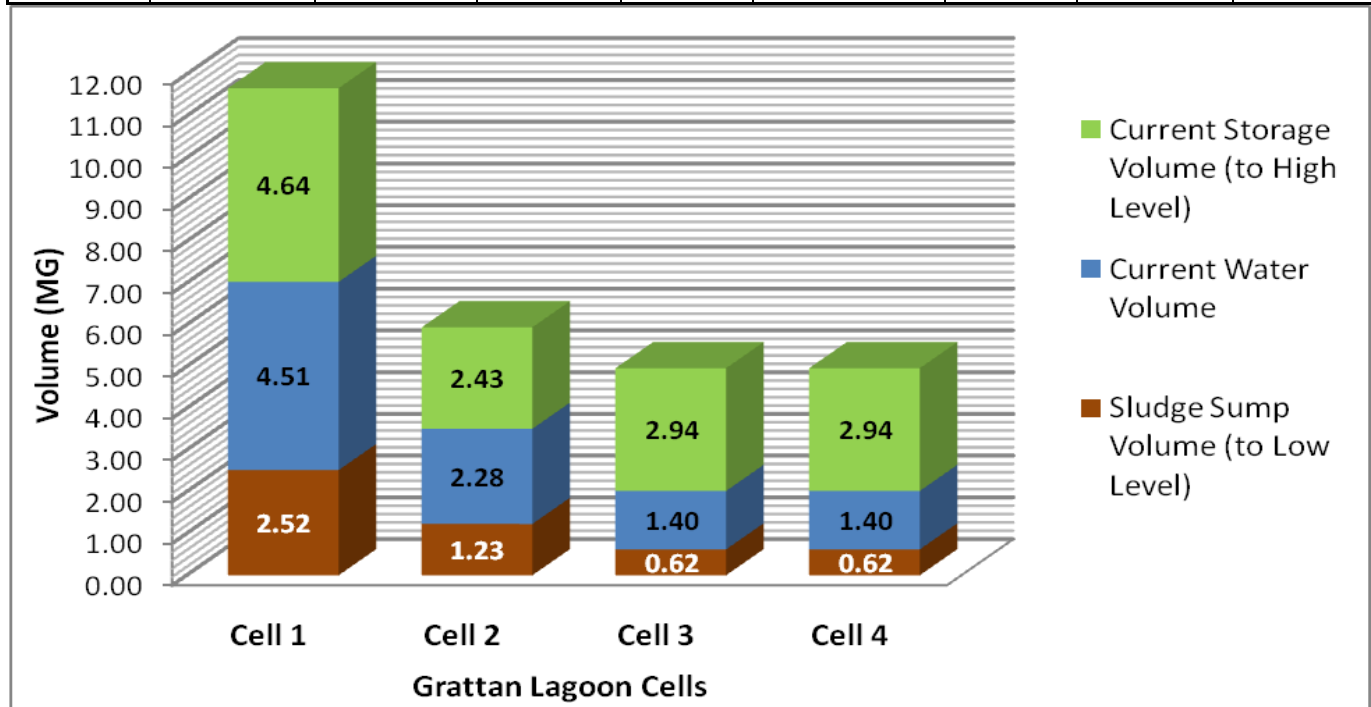
A snapshot of the individual and total lagoon volume and storage capacity (as of March 1, 2010) are shown below. The last graph will show the monthly total lagoons' volume with monthly wastewater flow totals. More detailed weekly data can be prepared on request.

March 1, 2010 Lagoon Levels	Feet Below Transfer / Pumping Structure Grating	Water Elevation (Top Structure Grating= 905.5')	Current Total Volume	Low Water Volume (Sludge Sump)	Current Water Volume (Current Volume Minus Sump Volume)	Current Storage Volume (To High Water Level)	Total WWTF Current Volume	Total WWTF Storage Volume (to High Water Level)
Cell 1	5.71 ft	899.79 ft	7.03 MG	2.52 MG	4.51 MG	4.64 MG	14.58 MG	12.95 MG
Cell 2	5.69 ft	899.81 ft	3.51 MG	1.23 MG	2.28 MG	2.43 MG		
Cell 3	9.75 ft	895.75 ft	2.02 MG	0.62 MG	1.40 MG	2.94 MG		
Cell 4	9.75 ft	895.75 ft	2.02 MG	0.62 MG	1.40 MG	2.94 MG

\*Data obtained from Prein&Newhof Lagoon Volume Calculator.

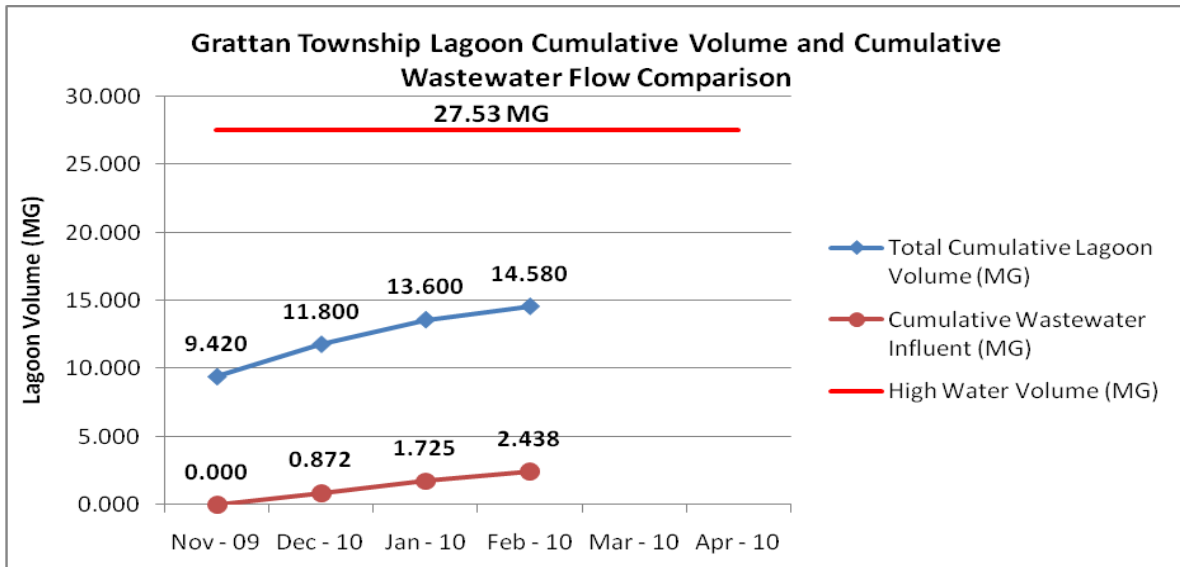
There was only a 0.267 MG difference from the total wastewater flow to the lagoons and the increase in lagoon volume. This would be from precipitation and snow/ice melt throughout the month.
