***Grattan Township and Grattan/Vergennes Sewer Systems Monthly
Operations Report***

January 2010

Grattan Township Sewer System

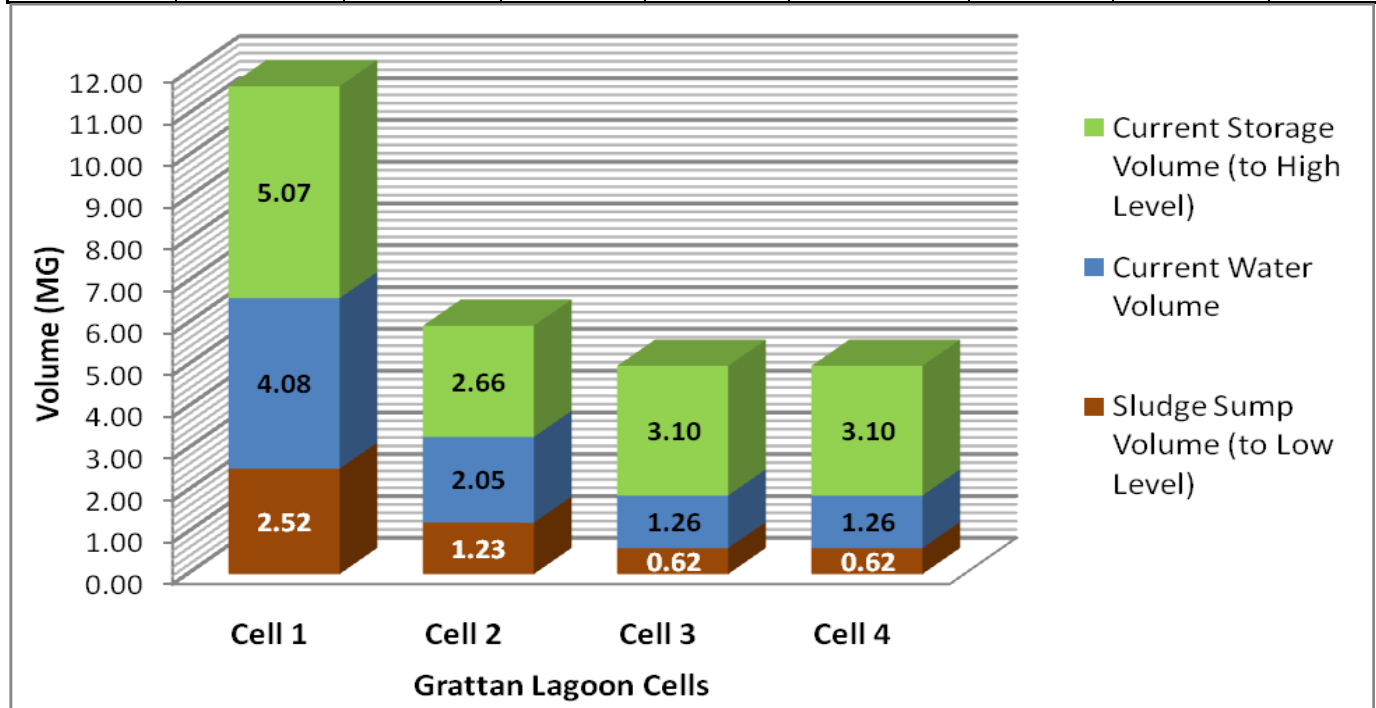
A snapshot of the individual and total lagoon volume and storage for February 1, 2010 are shown below. The last graph will show the monthly total lagoons' volume with monthly wastewater flow totals. More detailed weekly data can be prepared on request.

February 1, 2010 Lagoon Levels	Feet Below Transfer / Pumping Structure Grating	Water Elevation (Top Structure Grating= 905.5')	Current Total Volume	Low Water Volume (Sludge Sump)	Current Water Volume (Current Volume Minus Sump Volume)	Current Storage Volume (To High Water Level)	Total WWTF Current Volume	Total WWTF Storage Volume (to High Water Level)
Cell 1	6.13 ft	899.37 ft	6.60 MG	2.52 MG	4.08 MG	5.07 MG	13.60 MG	13.93 MG
Cell 2	6.13 ft	899.37 ft	3.28 MG	1.23 MG	2.05 MG	2.66 MG		
Cell 3	10.10 ft	895.40 ft	1.86 MG	0.62 MG	1.26 MG	3.10 MG		
Cell 4	10.10 ft	895.40 ft	1.86 MG	0.62 MG	1.26 MG	3.10 MG

*Data obtained from Prein&Newhof Lagoon Volume Calculator.

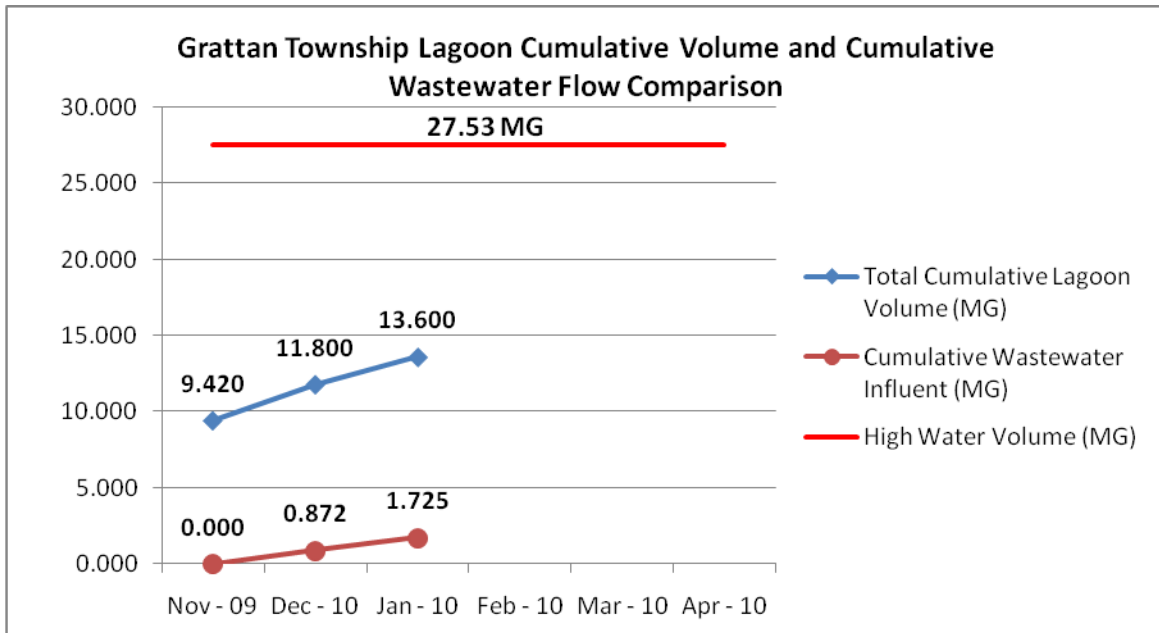
Once again there is a difference of approximately 1MG from precipitation in the lagoons. Monthly wastewater flow for January was approximately 0.853MG and the Lagoon volume increased 1.800MG. There were a couple of thaws in January which released earlier precipitation into the lagoons. However, the lagoon volume trend that is developing is assuring.
