Grattan Township and Grattan/Vergennes Sewer Systems
July 2010 Monthly Operations Report

Grattan Township Sewer System

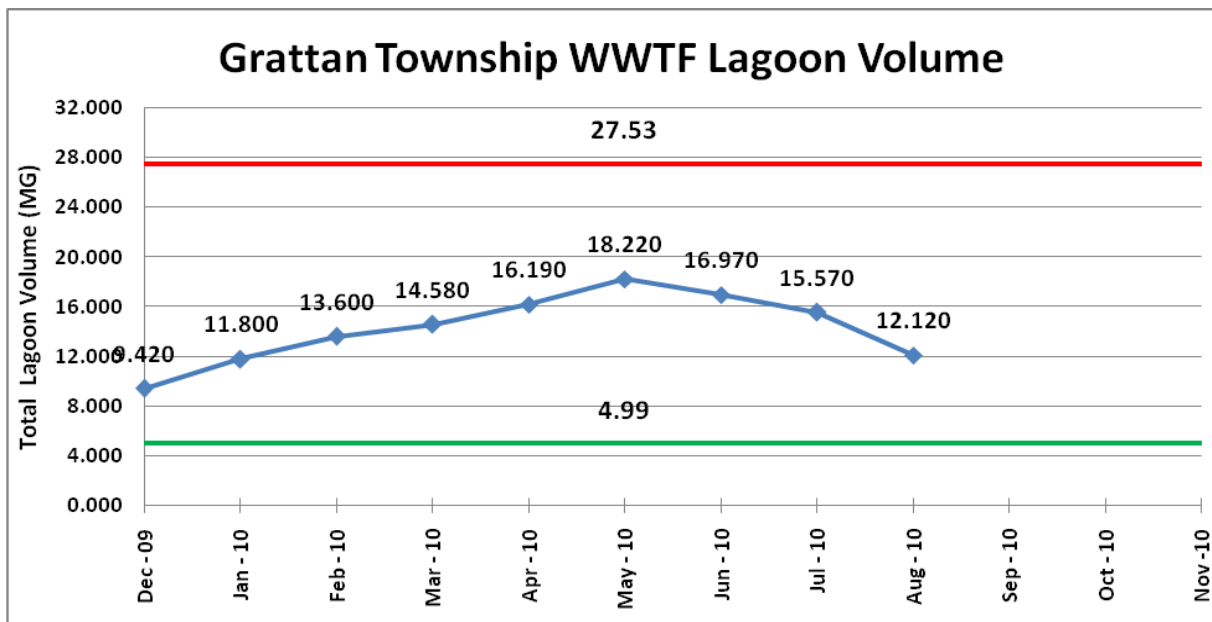
A total of 3.240MG has been discharged through the irrigation system at the Grattan WWTF. The lagoons had a decrease of 3.450MG over the same period. The wastewater influent flow for the month was 1.031MG, with an additional 0.813MG from rainfall¹ (calculated from 4.66” rainfall over ~280,000ft² lagoon surface areas). With these variables we are able to estimate the total evaporation for the month using the simple equation below:

$$-3.450\text{MG (Tot. Lag. Dec.)} = 1.031\text{MG (Inf.)} + 0.813\text{MG (Rain)} - 3.240\text{MG (Irr.)} - 2.054\text{MG (Evap.)}$$

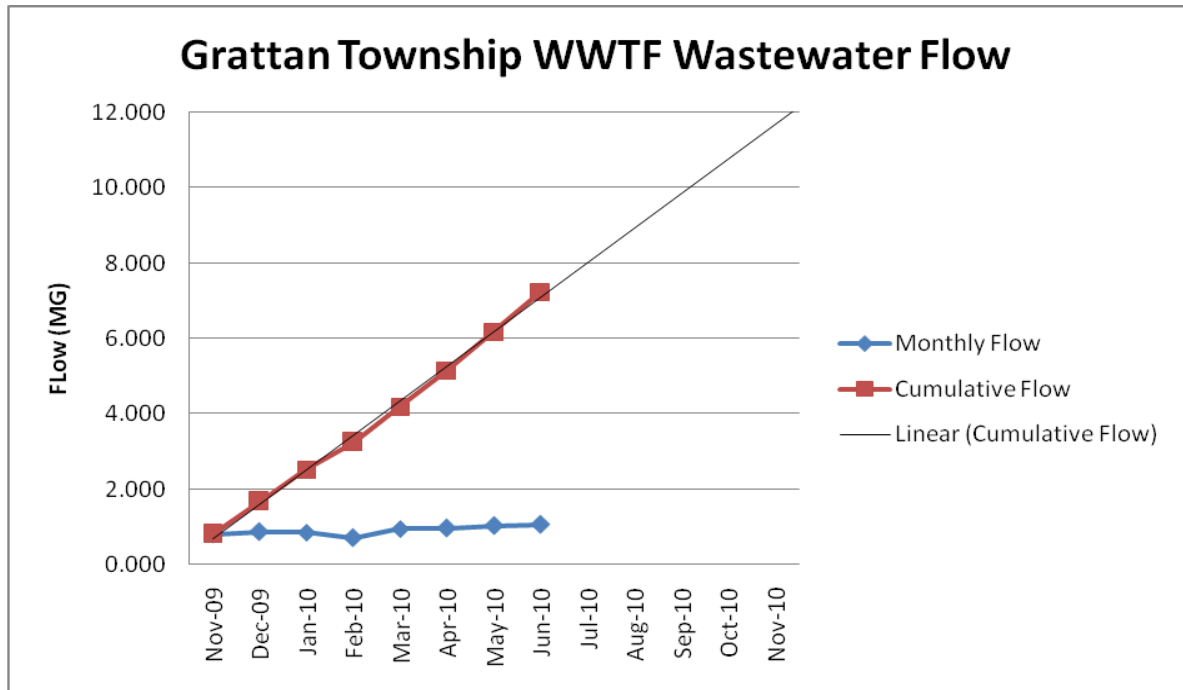
In addition, the following data shows the wastewater flow into the lagoons:

Grattan Township WWTF Wastewater Flow		
Month/Year	Monthly Flow	Cumulative Flow
Nov-09	0.798	0.798
Dec-09	0.872	1.670
Jan-10	0.853	2.523
Feb-10	0.713	3.236
Mar-10	0.955	4.191
Apr-10	0.964	5.155
May-10	1.023	6.178
Jun-10	1.060	7.238
Jul-10	1.031	8.269
Aug-10		
Sep-10		
Oct-10

2009 Irrigation Season
	2010 Storage Season
	2010 Irrigation Season
