.....
April 9, 2010

Grattan Township and Grattan/Vergennes Sewer Systems **March 2010 Monthly Operations Report**

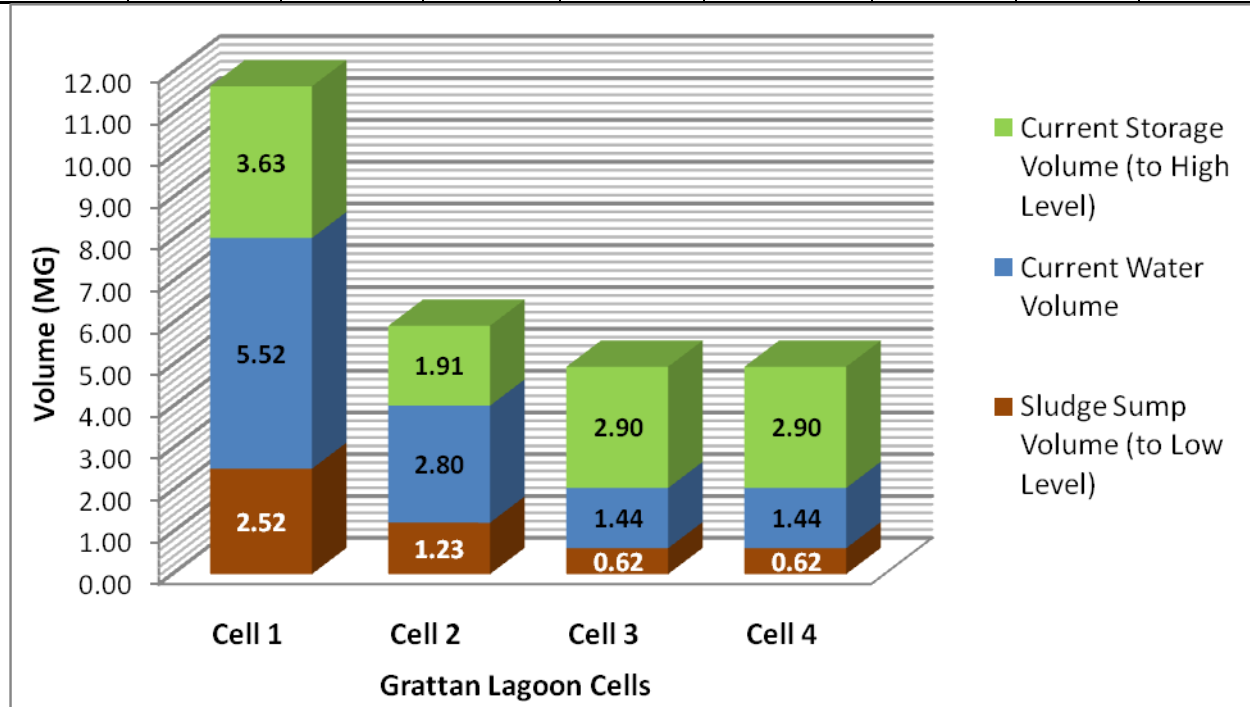
A snapshot of the individual and total lagoon volume and storage capacity (as of March 31, 2010) is shown below. The last graph will show the monthly total lagoons' volume with monthly wastewater flow totals. More detailed weekly data can be made available upon request.

March 31, 2010 Lagoon Levels	Feet Below Transfer / Pumping Structure Grating	Water Elevation (Top Structure Grating= 905.5')	Current Total Volume	Low Water Volume (Sludge Sump)	Current Water Volume (Current Volume Minus Sump Volume)	Current Storage Volume (To High Water Level)	Total WWTF Current Volume	Total WWTF Storage Volume (to High Water Level)
Cell 1	5.00 ft	900.50 ft	8.04 MG	2.52 MG	5.52 MG	3.63 MG	16.19 MG	11.34 MG
Cell 2	5.00 ft	900.50 ft	4.03 MG	1.23 MG	2.80 MG	1.91 MG		
Cell 3	9.60 ft	895.90 ft	2.06 MG	0.62 MG	1.44 MG	2.90 MG		
Cell 4	9.60 ft	895.90 ft	2.06 MG	0.62 MG	1.44 MG	2.90 MG

*Data obtained from Prein&Newhof Lagoon Volume Calculator.

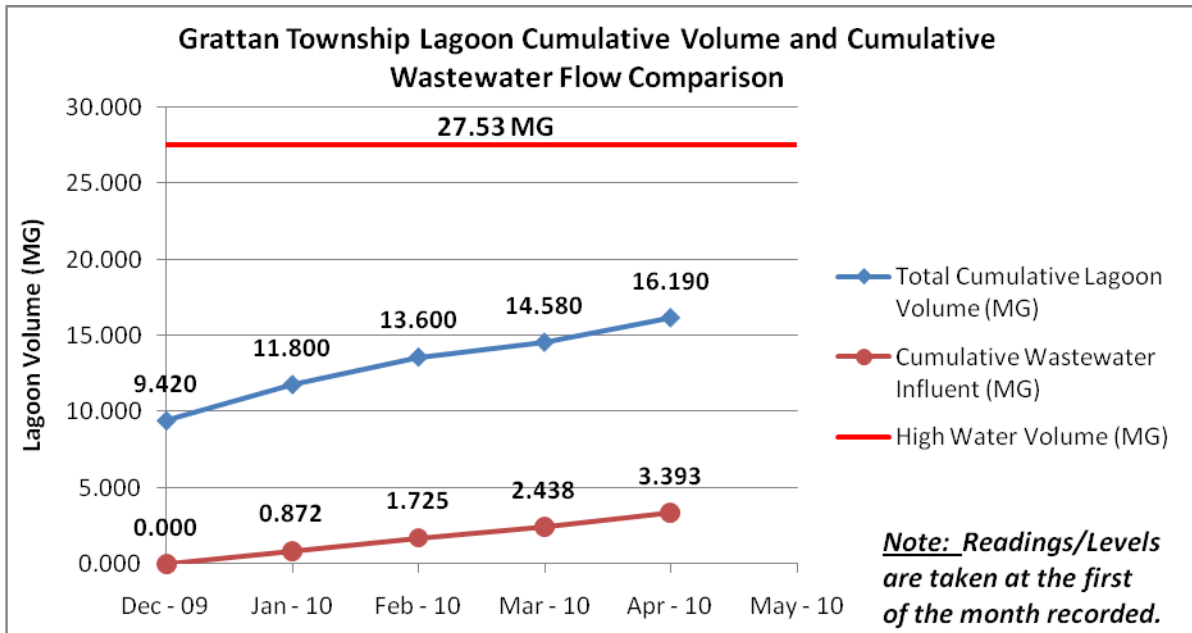
There was an additional 0.655 MG to the total wastewater flow to the lagoons to equal the increase to the total lagoon volume over the same time period.
