Grattan Township and Grattan/Vergennes Sewer Systems **April 2010 Monthly Operations Report**

Grattan Township Sewer System

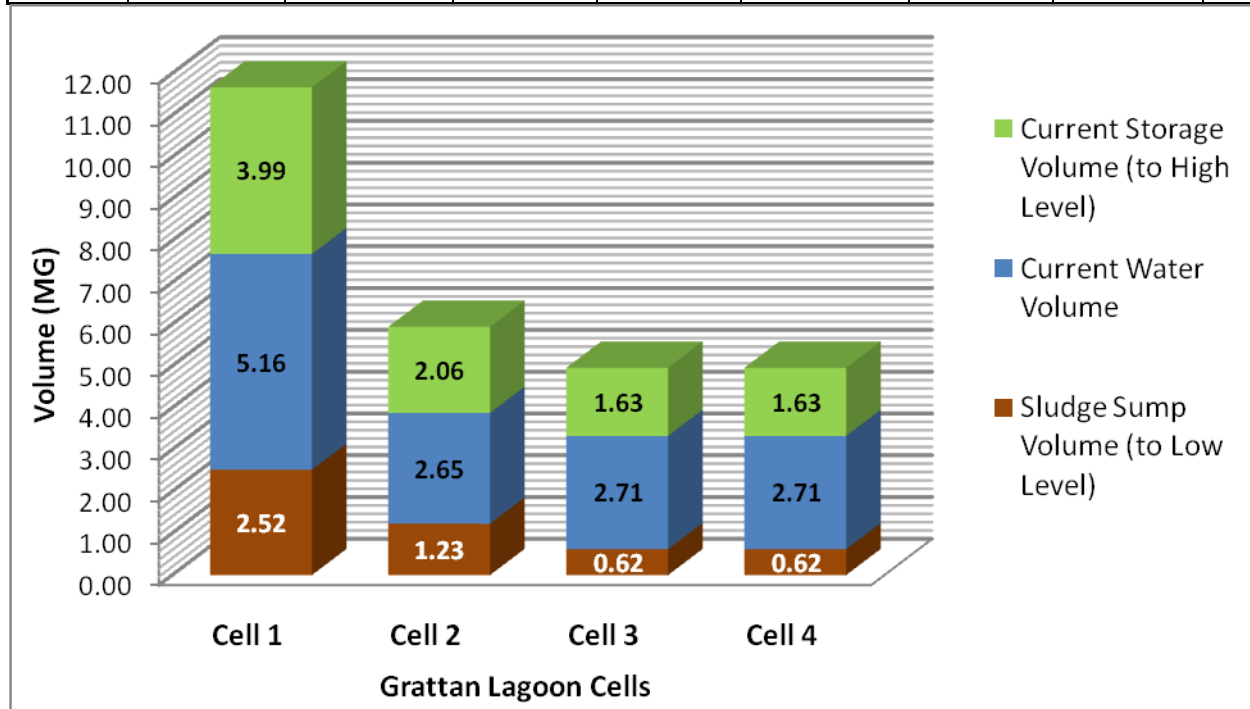
May 1, 2010 Lagoon Levels	Feet Below Transfer / Pumping Structure Grating	Water Elevation (Top Structure Grating= 905.5')	Current Total Volume	Low Water Volume (Sludge Sump)	Current Water Volume (Current Volume Minus Sump Volume)	Current Storage Volume (To High Water Level)	Total WWTF Current Volume	Total WWTF Storage Volume (to High Water Level)
Cell 1	5.25 ft	900.25 ft	7.68 MG	2.52 MG	5.16 MG	3.99 MG	18.22 MG	9.31 MG
Cell 2	5.20 ft	900.30 ft	3.88 MG	1.23 MG	2.65 MG	2.06 MG		
Cell 3	6.70 ft	898.80 ft	3.33 MG	0.62 MG	2.71 MG	1.63 MG		
Cell 4	6.70 ft	898.80 ft	3.33 MG	0.62 MG	2.71 MG	1.63 MG

*Data obtained from Prein&Newhof Lagoon Volume Calculator.

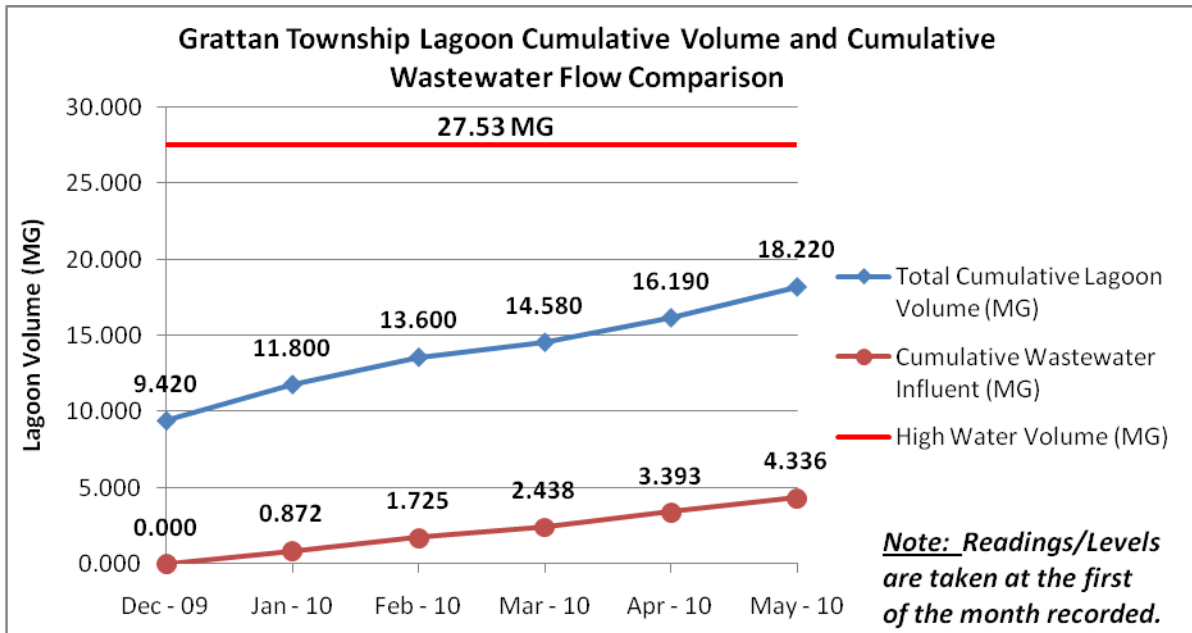
There was an additional 0.655 MG to the total wastewater flow to the lagoons to equal the increase to the total lagoon volume over the same time period.
