Grattan Township and Grattan/Vergennes Sewer Systems
June 2011 Monthly Operations Report

Grattan Township Wastewater System

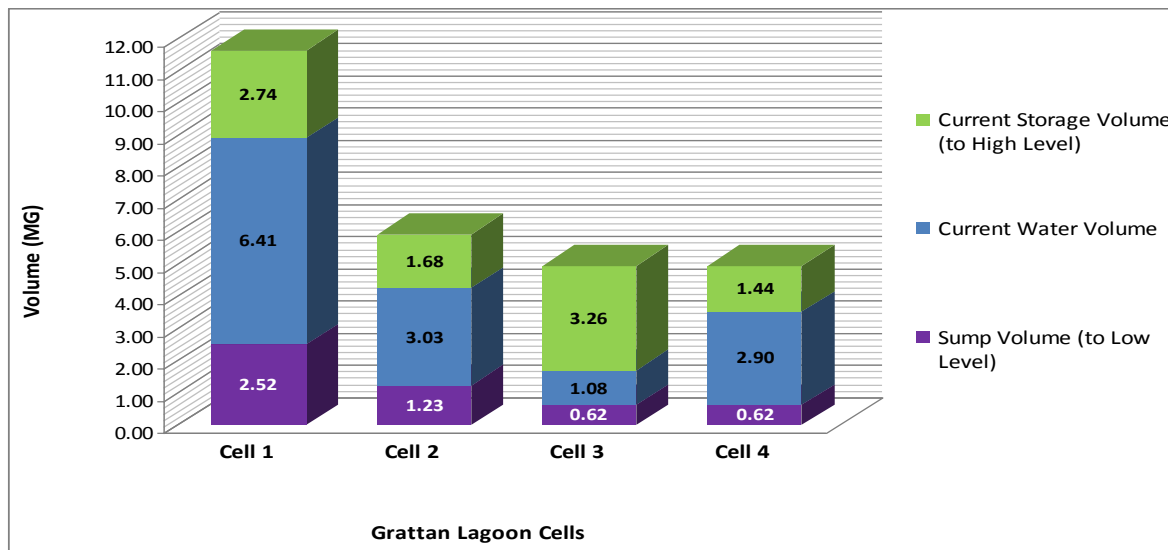
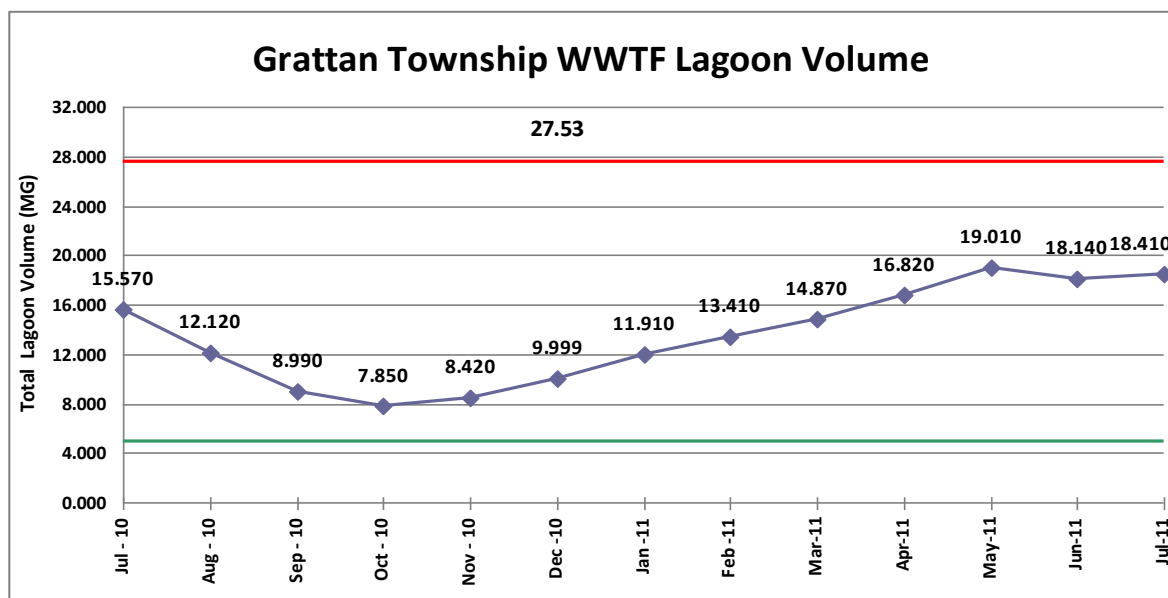
The following shows the relationship of these variables (which now combines the net rainfall and evaporation):

$$0.270\text{MG (Tot. Lag. Inc.)} = 1.302\text{MG (Inf.)} - 1.731\text{MG (Irr.)} + 0.699\text{MG (Net Precip/Evap)}$$

The monthly CMR for June 2011 is currently being prepared for submission to the DNRE. There was 1.731MG discharged throughout the month of June. The wastewater influent flow for the month of June was 1.302MG. The Grattan WWTF total lagoon volume had an increase of 0.27MG over the month of June. This increase was due to the number of days either no or partial irrigation allowable because of the farmer's request or rainfall.
