***Grattan Township and Grattan/Vergennes Sewer Systems***  
**May 2010 Monthly Operations Report**

## Grattan Township Sewer System

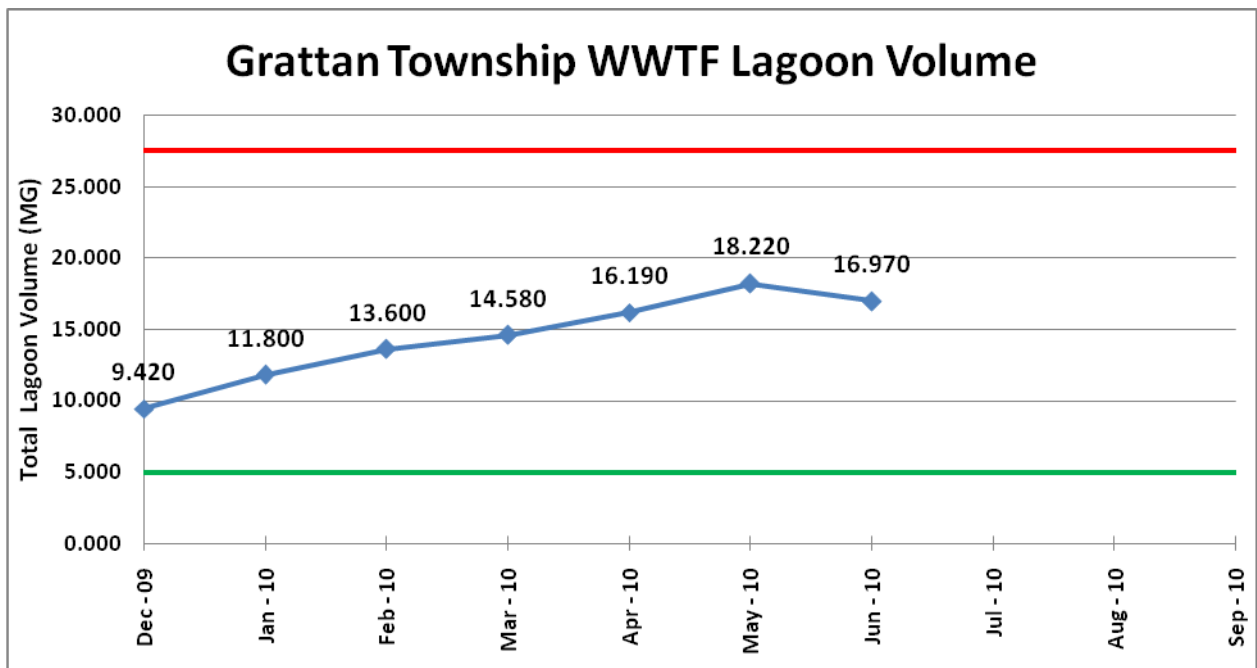
A total of 3.079MG has been discharged through the irrigation system at the Grattan WWTF. The DNRE has pro-actively approved the increase to 2.35"/week (from 2.00"/week) which has been in effect since the first week of irrigation. The chart below shows the monthly total lagoon volume and discharge volume. More detailed weekly data can be made available upon request.

The WWTF began its seasonal discharge through the existing irrigation season. There was 4.504MG discharged through the month of May. Williams & Works is currently preparing specifications for replacement of the irrigation system as required by the DNRE.
